REPAIR YOUR PIPES FROM THE INSIDE WITH NUFLOW.

NuFlow is a proven pipe lining technology that restores and renews old, broken or corroded pipes to a “like new” condition without the need to remove or replace them. Our NuDrain cured-in-place pipe lining process does not require any digging or destruction to your property and therefore translates to less mess, less cost, and minimal disruption to your everyday business.

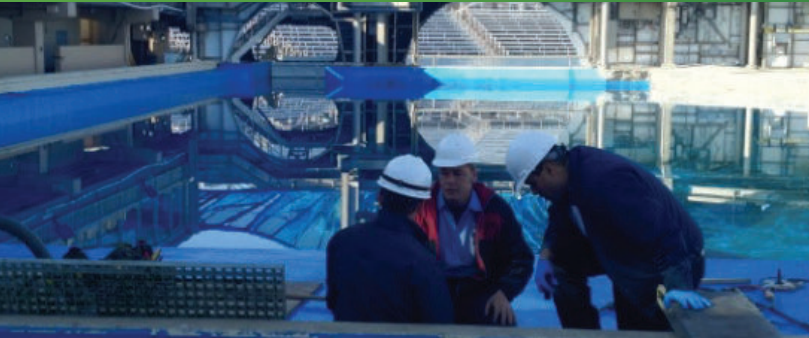
**Southern California Theme Park:
Underground Drain Line Rehabilitation**

SITUATION: 14" to 24" diameter pipes, including a custom 14" by 19" transitional 90-degree elbow, ran beneath large pools, experienced chronic failure. The customer needed a long-term solution that would keep the pool and surrounding landscape intact, as well as cause as little disruption to the theme park as possible.

SOLUTION: NuFlow installed our NuDrain structural liner using our unique and innovative pull-in-place technology. This liner will protect the inside of the pipeline and prevent leaks. The customer was so happy with our solution that the company scheduled more work for us to do in that park as well as others across the nation.

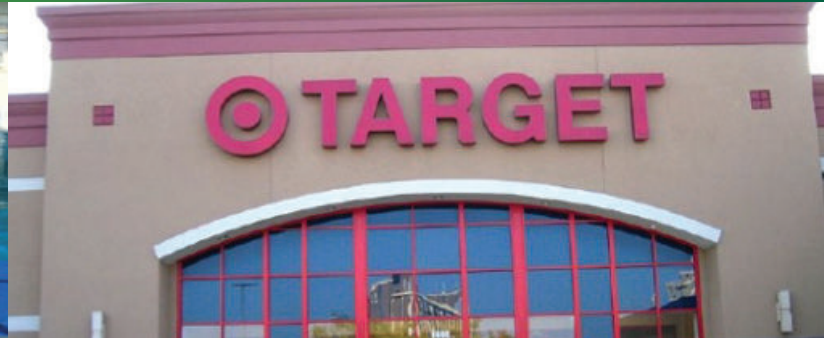
**Target: Underground Sanitary Branch Line
Rehabilitation**

SITUATION: An aged sanitary branch line below the Target's food court experienced backups and limited flow. This pipeline is located beneath the concrete and product displays. The pipeline was jetted years prior, but the problems still returned. The customer wanted a long-term solution that would not disrupt operations.

SOLUTION: NuFlow rehabilitated the failing pipe without having to move or unplug any equipment. Our technicians worked while the store was closed at night, and the food court operated normally during business hours. NuFlow's pull-in-place structural liner was installed to prevent future problems.

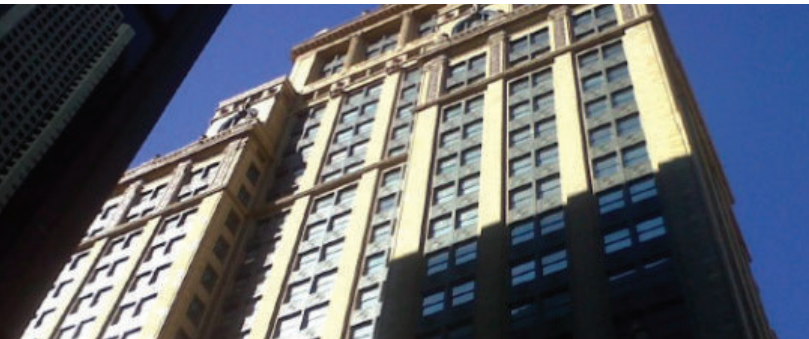
**Temple Emanu-El:
Roof Drain System Rehabilitation**

SITUATION: The 10 roof drains encased in concrete pillars were rotten, had leaks and could have destroyed the historical temple from within. The roof drains run through 12-story columns in the middle of the synagogue.

SOLUTION: NuFlow's trenchless technology preserved the historic temple and the interior columns, causing minimal disruption to the temple's normal operations. NuFlow's pull-in-place structural liner created a new pipe within the existing host pipes, protecting the drain system from future problems.

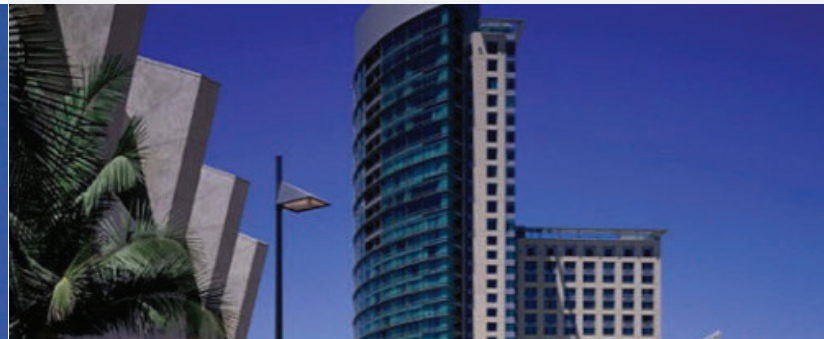
Omni Hotel: Sewer Drain Line Rehabilitation

SITUATION: The waterfront hotel sits at sea level, with its parking structure below the hotel. Beneath an 18" slab, the hotel's sanitary drain line runs below the ocean's water table. The corrosive ocean water ate away at a 70 foot run of 4" cast iron pipe, leaving a large channel missing from the bottom of the pipe.

SOLUTION: After a traditional spot repair by another company failed, the hotel hired NuFlow to install our pull-in-place, seamless liner into the drain system. Our no-dig technology did not cause unsightly construction, and the retrofit liner will protect the pipes from the ocean water.
